Manhole Inspection Summary

Manhole # S21KK1005MH

Location Address: **4418 LAPLATA AVE**

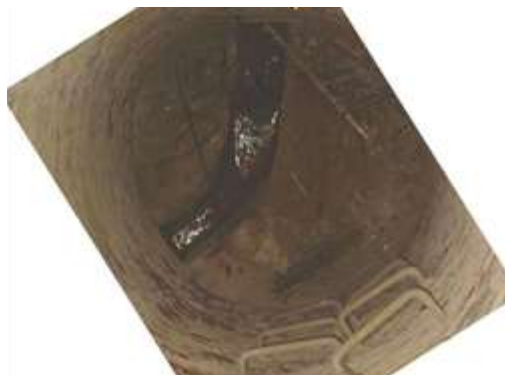
Top View

Adjustment, Corbel, and Barrel infiltration.
Bench debris.

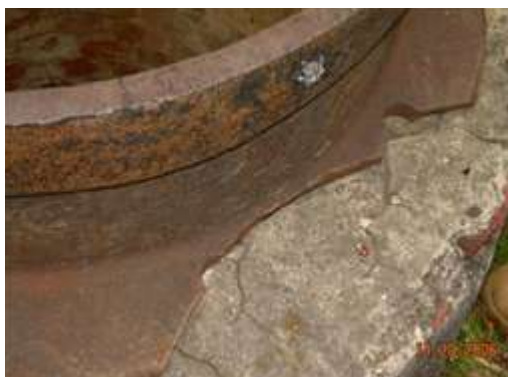
Defect

Frame Offset: **1** (in.) Condition: ☐ Sound ☒ **Cracked** ☒ **Leaks**

Cracked frame.

Comments **The rim needs to be reset.**

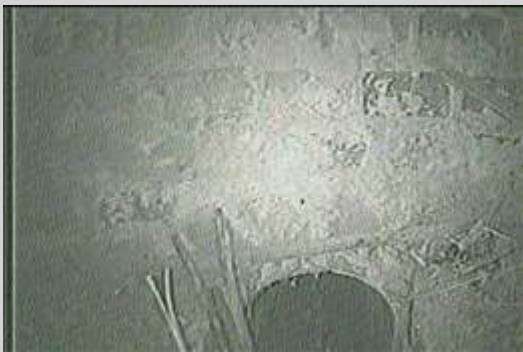
8 in. Circular Gravity Sewer Pipe Out @ 12 O'Clock

Infiltration: **Evidence** Pipe Seal Cond: **Unknown**

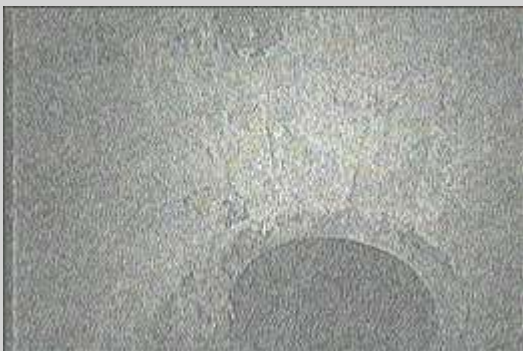
8 in. Circular Gravity Sewer Pipe In @ 7 O'Clock

Infiltration: **Evidence** Pipe Seal Cond: **Unknown**
